# Leading Edge erosion and pollution from wind turbine blades

5 th. Edition - English

"THE TURBINE GROUP" JULY 2021

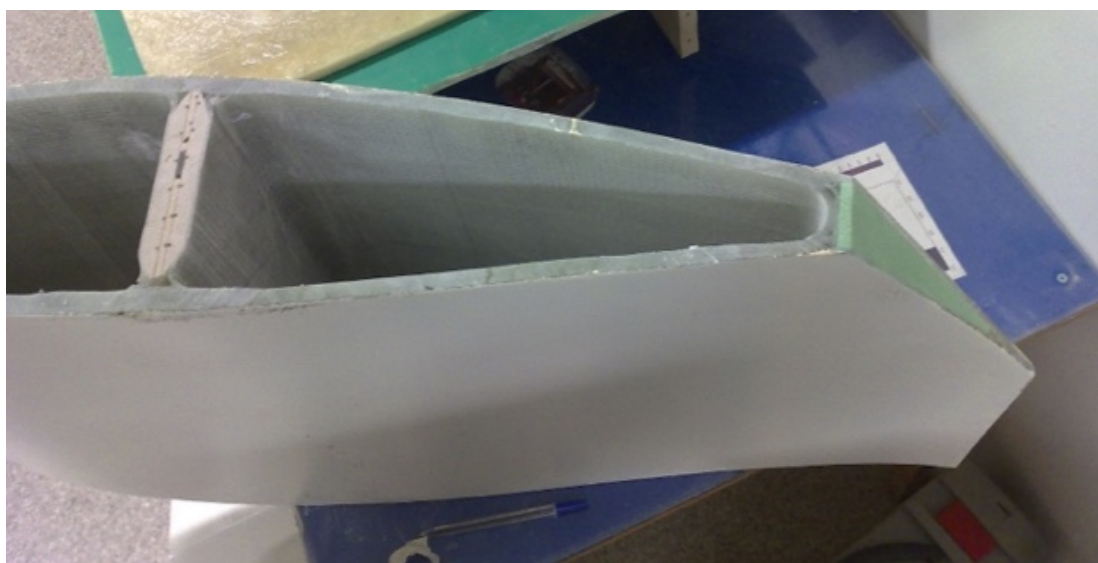
Figure 5 Photo: A small blade profile - to get an impression of proportions. Own photo, from testing

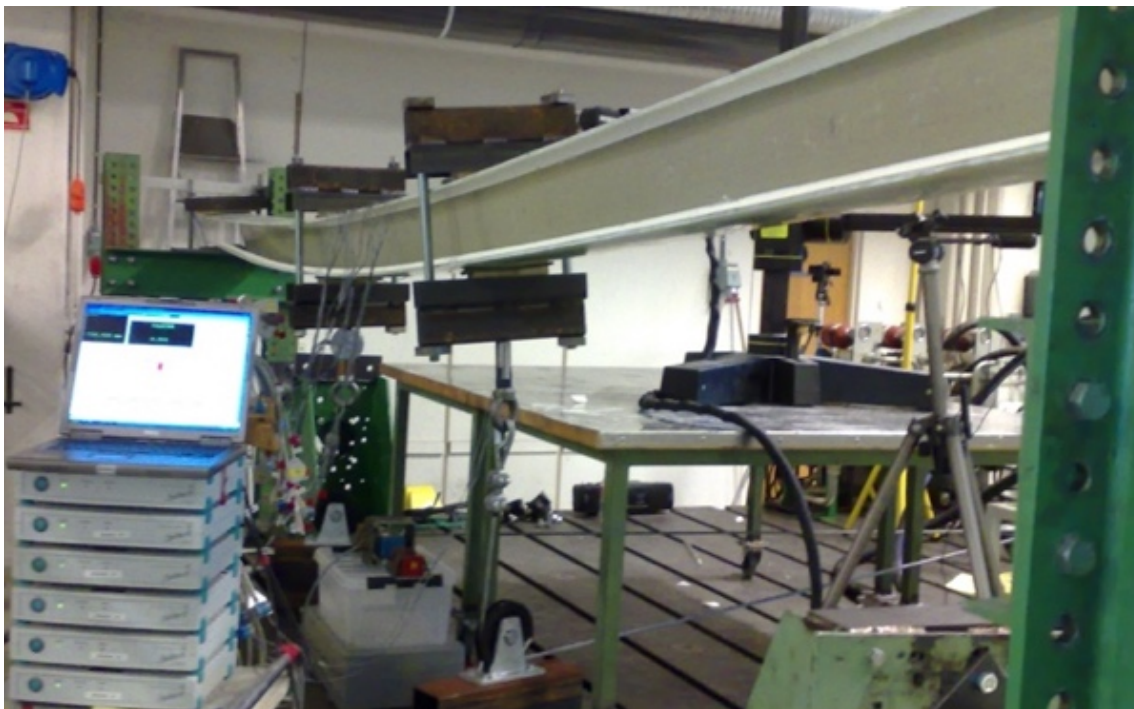
Figure 7 Photo: Bending test of a section on a wing profile. Own photo, from testing
